Workshop Manual

Wheels, rim and tyre specifications

Edition 07.2011

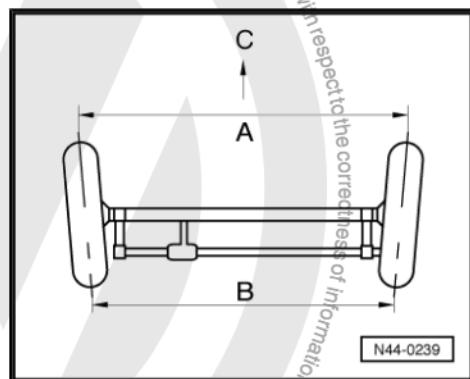
Fast travel in curvy stretches causes greater wear especially on the tyre's outer shoulder.

A rounded tyre outer shoulder, together with a pronounced wear of the tyre surface outer blocks, indicate that curves were taken at high speed. This wear situation is a consequence of driving style.

To optimize the behaviour of the moving vehicle, the values of the convergence angles and of the camber must be adjusted. If the tires roll in conditions other than those indicated, there unilateral, greater wear.

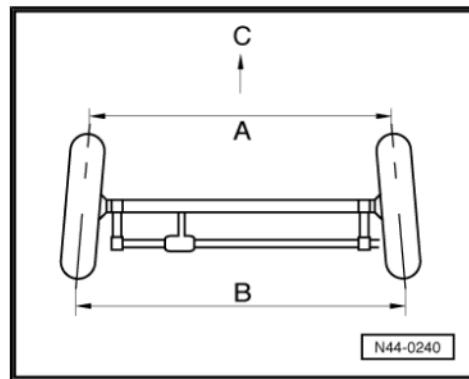
Irregular wear will be the following consequence:

Inadequate use of running gear leveling with pneumatic suspension.

Using Off-road - Level adjustment is only recommended for all terrain driving. Permanently using Off-road - Level adjustment in normal driving conditions on the road may cause great tyre wear, because the height change modifies the position of the wheels in relation to the floor level.

To prevent unilateral tyre damage, on one side, the correct axle geometry adjustment must be ensured, while on the other side the vehicle must be used appropriately.

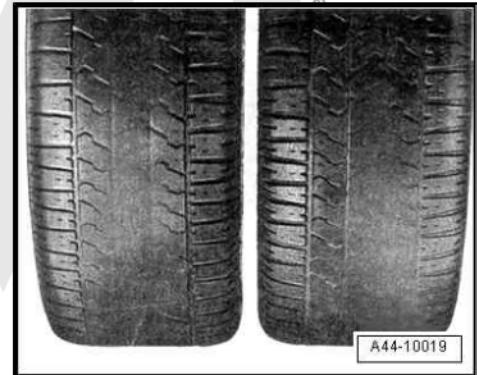
This wear condition can be seen on the driving wheels of powerful vehicles that ride long distances at high speeds.

At high speeds, and due to centrifugal force, the diameter of wheels increases more at the centre portion of tyre's tread than

on the tyre's shoulders. Consequently the propulsion force is transmitted up from the center area of tyre tread on the asphalt surface. This is reflected on the wear condition.

These symptoms are noticeable especially on wide tyres.

The reduction of air pressure on the tyres does not change this wear condition.

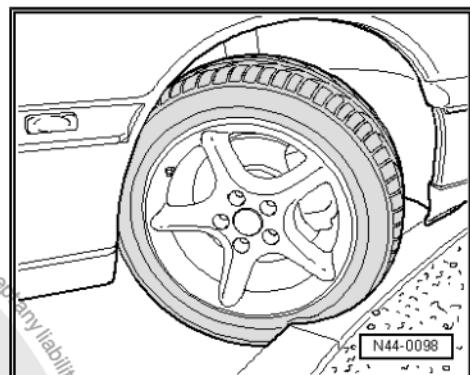
2.5.3 Damages caused by crashes

A „crushing (crease)“ on the tyre rubber wall indicates that the case was damaged in the sub-frame of the tyre.

One of the typical causes for these types of damages is, for example, when the vehicle climbs a sidewalk curb where there is an acute angle.

- ◆ *Avoid climbing the sidewalk curbs.*
- ◆ *If unavoidable, climb the sidewalk by keeping the straightest angle possible.*

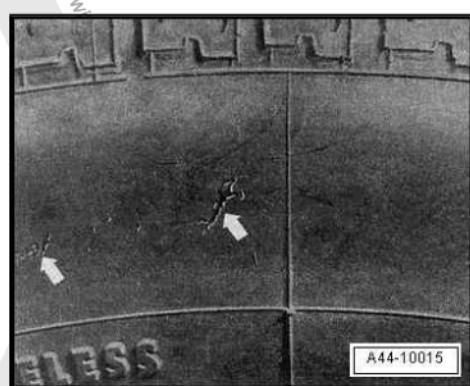
Inner view of a tyre with broken case, due to strong impact. The case was smashed on the wheel rim and is broken on the contact zone.

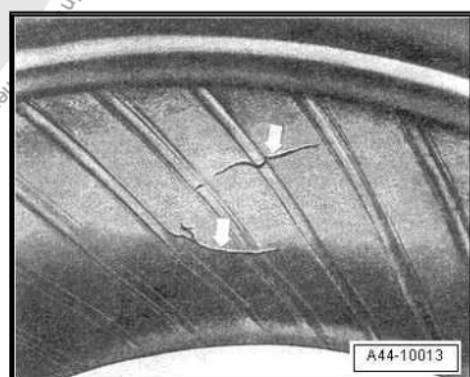
Damage in the inner portion of a tyre due to a crash (double rupture)

Double rupture -arrows-, due to compression when climbing.
Usually not identifiable from the outer portion.

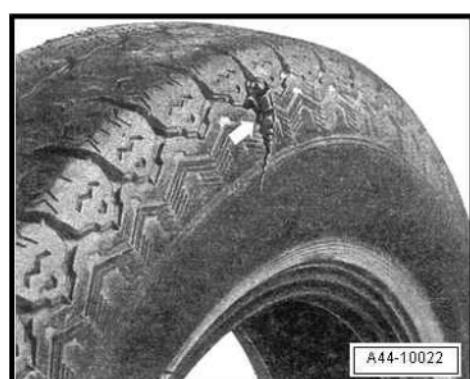
Cut caused by pointed obstacle -arrow-

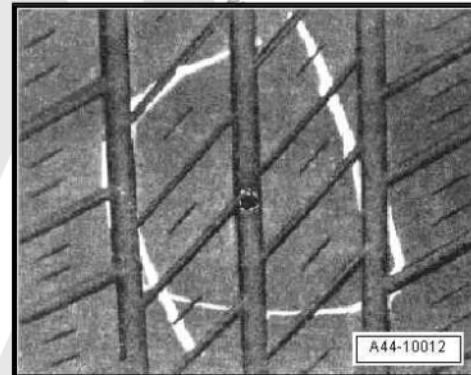
Damage caused by a strange body thrust in

Sometimes, the strange body -mark- is driven so firmly on the tyre that even at high speeds it is not released. In this case, it may play a plug role and seal the tyre relatively well. The consequence consist in the slow loss of air, not immediately detected by the driver, but it may cause the tyre to become totally unusable.

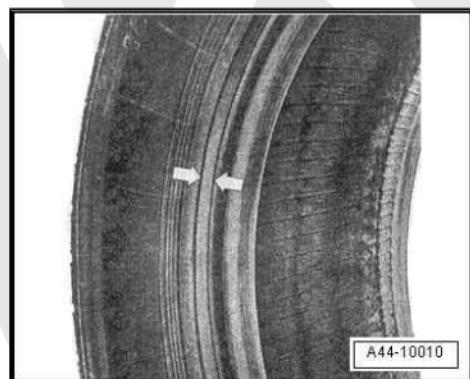
Tyres with wide depressions around them at the tyre bead area

Wide depressions around the bead area -arrows- are evidences of driving with insufficient air pressure.

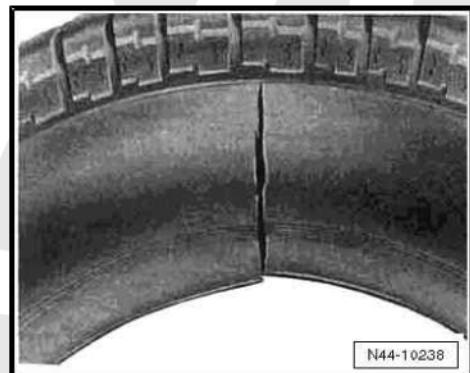
Tyre with damaged tyre bead core and destroyed case

The figure shows a tyre with the bead broken and the case destroyed due to excessive stress during the assembly.
